**DOT/FAA/AR-99/20, P1**

# **Development of a Supplemental Inspection Document for the Fairchild SA226 and SA227 Aircraft, Part 1**

Technical Report

14. Sponsoring Agency Code  ACE-100	
15. Supplementary Notes  The FAA William J. Hughes Technical Center manager was Mr. Xiaogong Lee.			
16. Abstract  This report is the first phase of a three-phase program sponsored by the Federal Aviation Administration to develop a supplemental inspection document for Fairchild SA226 and SA227 aircraft. In this report, the mission profiles for the aircraft are established. The principal structural elements are defined, and the operating stresses are established.

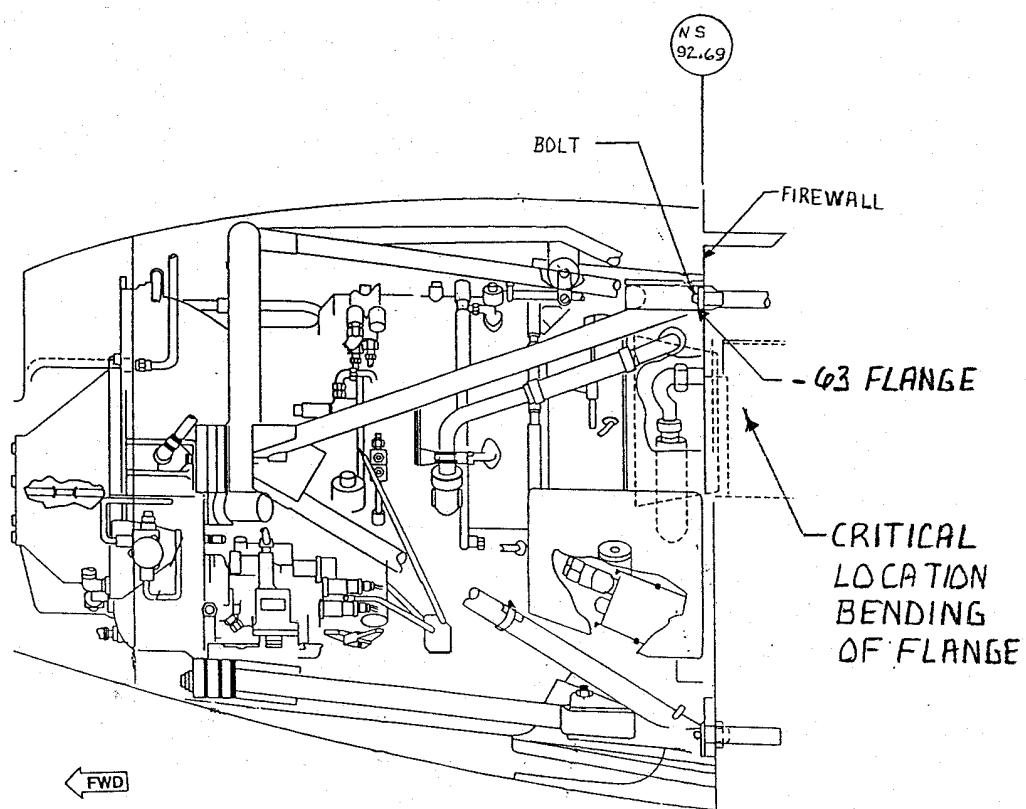
**FIGURE 6-32 EM1 - SA227 ENGINE MOUNT AT FIREWALL**

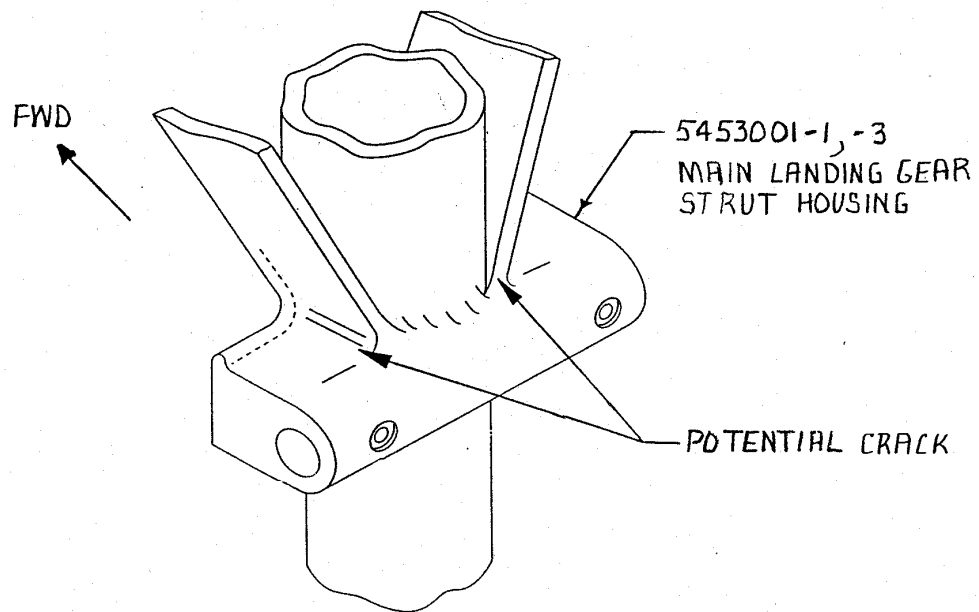
**FIGURE 6-33 LG2 - MAIN LANDING GEAR STRUT**

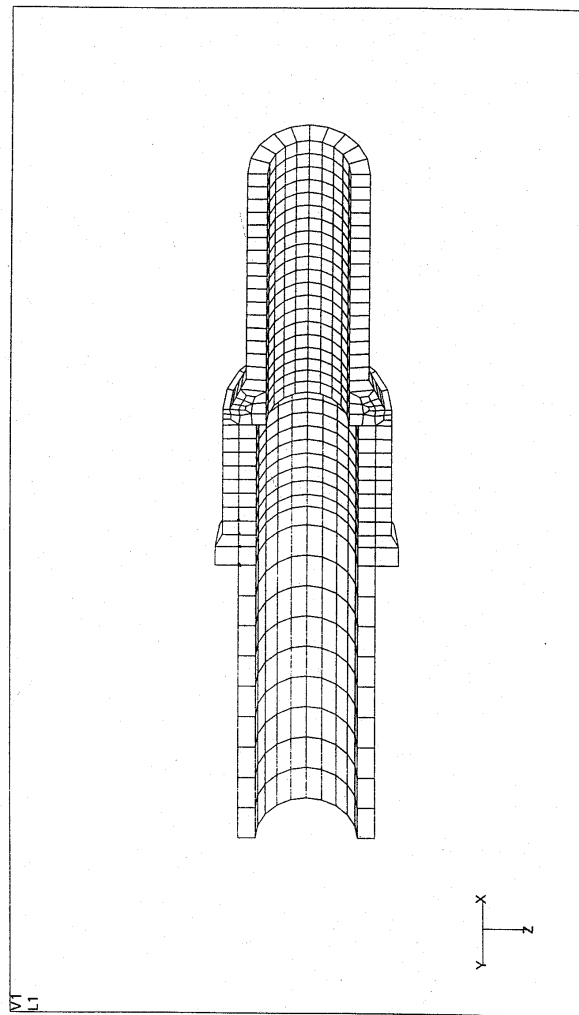
**FIGURE 6-34 METRO III MAIN LANDING GEAR FINITE ELEMENT MODEL**

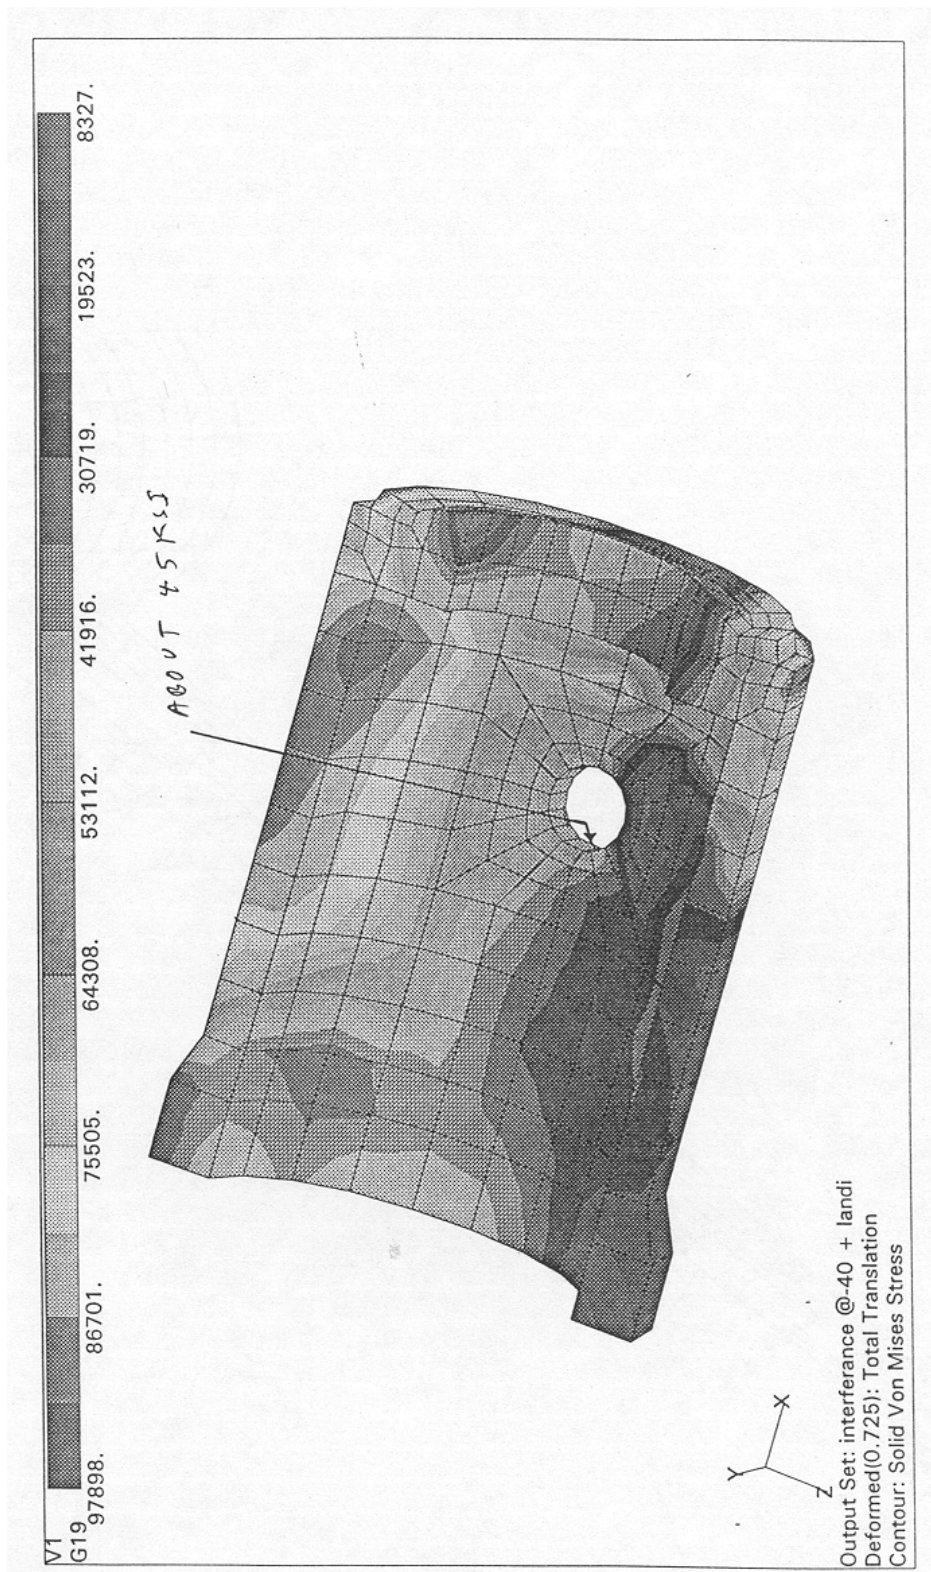
**FIGURE 6-35 MAIN LANDING GEAR FINITE ELEMENT MODEL**

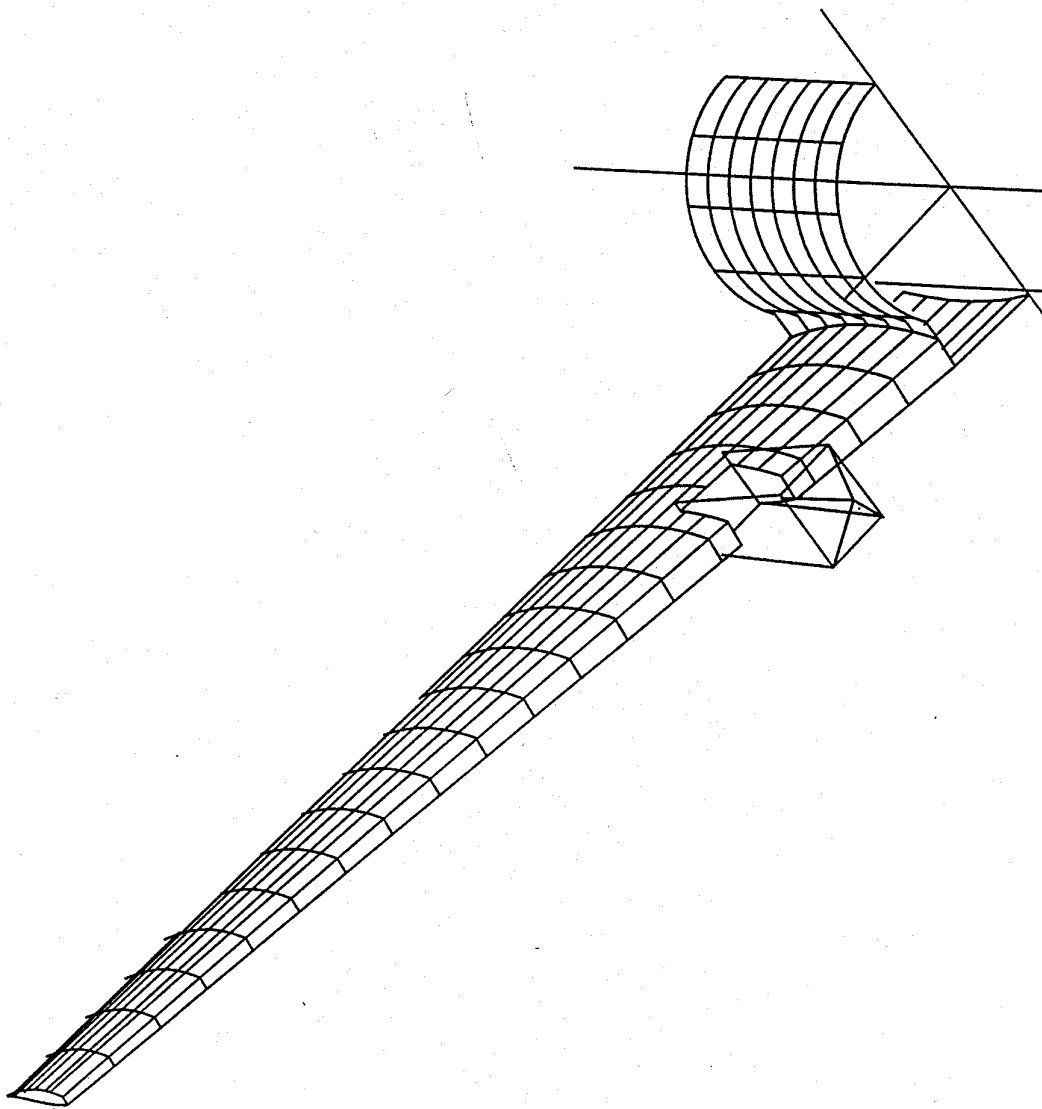
**FIGURE 6-36 WING FINITE ELEMENT MODEL**

The wing finite element model shown in Figure 6-36 was used to analyze the SA227 wing. The distributions were checked during the SA227 wing static test and shown to be within about 1% of the measured stress for the more heavily loaded portions of the wing. These analysis results can be used to determine stresses at locations other than the strain gage locations.

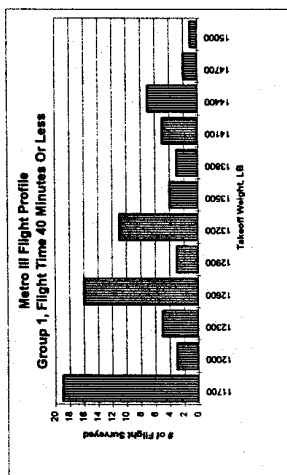
Wt. (+1 std dev) 13,765  
Wt. Average 12,753  
Wt. (-1 std dev) 11,741

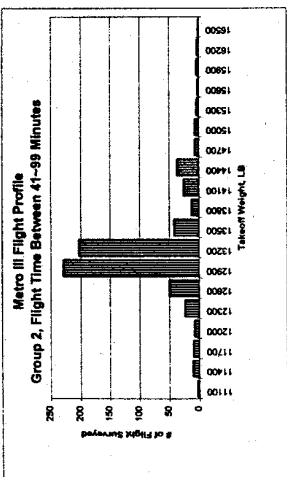
Wt. (+1 std dev) 13,901  
Wt. Average 13,274  
Wt. (-1 std dev) 12,847

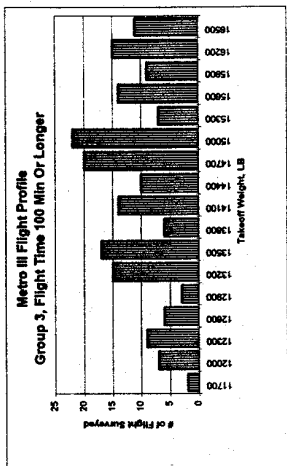
Wt. (+1 std dev) 14,916  
Wt. Average 13,826  
Wt. (-1 std dev) 12,737
